# Fiberglass and resin composite deck for temporary bridges

**ABSTRACT:** Decks suffer the greatest deterioration among the various components of a bridge. The interest in using composite materials in engineering applications is increasing worldwide, and Glass Fiber Reinforced Polymers (GFRP) offers the best cost- benefit ratio. The aim of this research is to evaluate experimentally the performance of GFRP deck for application in a Bailey bridge. The tested deck panels were manufactured by pultrusion and manual lamination. The experimental program consisted in obtaining physical and mechanical properties of the panels' materials and the bending and fatigue behavior of the panels. The load applied corresponded to the wheel load of an Astros 2020 vehicle. The bending tests revealed that the decks present high bending resistance, great deformability, and low resistance to shear. The panels meet the limit deflection and resistance required for vehicles with service loads up to 25 kN per wheel.

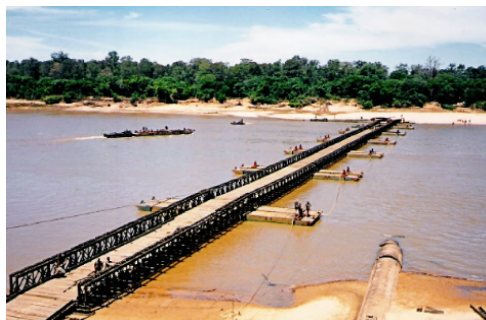
Fig. 4 – Bailey bridge (supported on unilocks). Source: [23].

**Figure 4** shows a Bailey bridge supported by uniflotes. Its construction does not require special or heavy equipment. Its knowledge and assembly are part of the school curriculum of all career military personnel (officers and sergeants) in the Engineering branch. The bridge deck suffers a high level of wear due to the rotting of the wooden planks and consequent corrosion of the metallic deck panels. [1, 21-23]

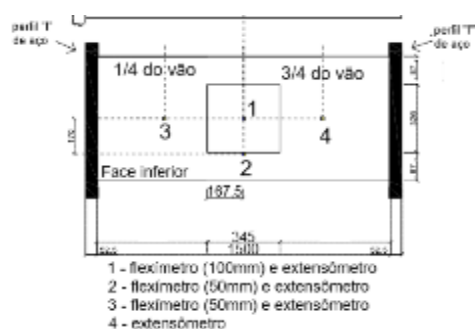
**Fig. 8** — Instrumentation of the panels. Source: [1].

The panels were instrumented with four electrical resistance strain gauges, in the longitudinal direction of the panel and two LVDT, all in the lower part of the panel. **Figure 8** shows the arrangement of strain gauges and LVDT on the bottom of the deck and **figure 9** shows the instrumented panel on the supports.

The LVDTs were withdrawn on cycle 113,313 for fear of equipment damage due to cyclic loading and possible panel rupture. **Figure 13** presents the load x sag curves of the LVDT in position 1 (see **figure 8**). From the analysis of the curves, it is verified that there was no loss of stiffness of the C3 panel due to the fatigue test up to cycle 113.313.

After carrying out the fatigue test, the bending panel rupture test was carried out. In this test LVDT were used in positions 1 and 2 (see **figure 8**). The load levels adopted were the same as for the other panels. The panel held up well to all landings, showing no visible signs of damage and no creaking of the material having been heard. At the standard load of 48.9 kN, the recorded deflection was approximately 6.36 mm, corresponding to  $L/192$ , having been 11.7% smaller than the deflection obtained in the C2 panel test for the same span and load.
